# A Preliminary Architectural Assessment of the Long Point Road Elementary School in the Snowden Community, Charleston County, South Carolina

#### **Project Introduction**

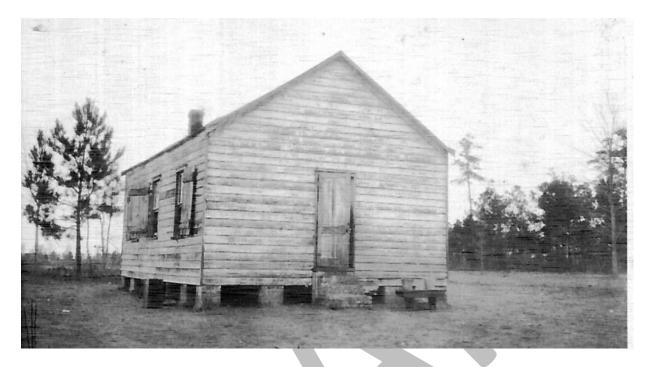
was shared by Robert MacDonald along with a 1955 image of the Long Point Rd School. Upon examination of the unidentified photo and the physical evidence, it can be said with great confidence that this is an image of Phase I of the Long Point Road Elementary School.

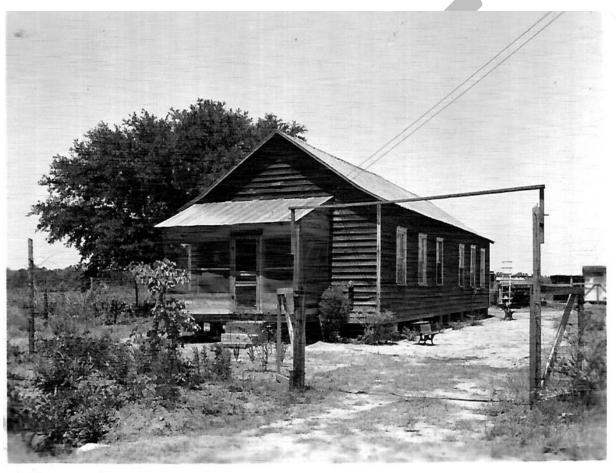
## Song Point Elementary School Photograph May 16, 1955

At some point after the school was completed, likely in the 1930s or early 1940s the schoolhouse as doubled in size. A room identical in size was added what would have been the rear of the structure. The framing of this extension was not visible during the research period as it is completed obscured by later modifications. It is expected that after the schoolhouse is moved in coming months that a more thorough investigation of this phase may be undertaken.

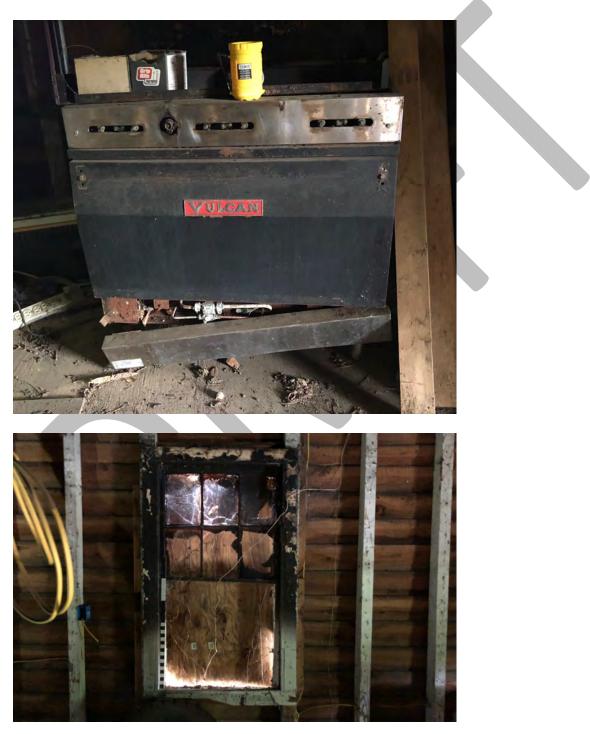
After Jennie Moore Elementary School was completed in 1953, the Long Point Road Elementary was surplus to the needs of the community. It was converted into a residence during the late 1950s and 1960s. The mother of the current owners resided here at this point through the 1980s. A Vulcan brand industrial gas oven was installed at this point and was likely the cause of a damaging fire resulting in the Phase IV modifications.

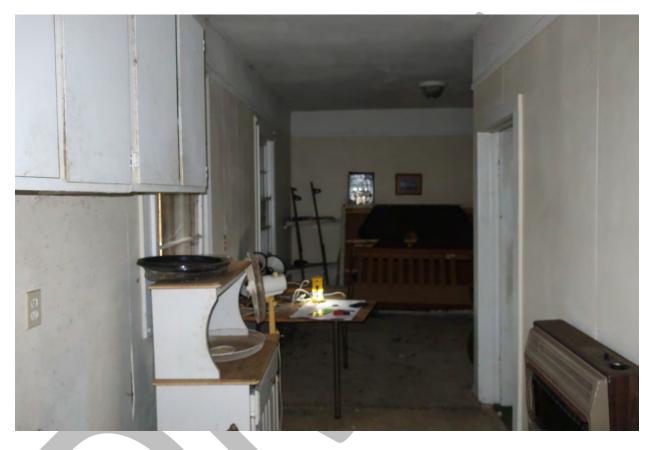
A relatively recent fire resulted in the removal of the majority of beadboard in the Phase I section of the structure. This exposed the original framing. New rooms have been framed but not drywalled in the Phase I area. The Phase II portion of the structure has been completed with two bedrooms, a sitting room, kitchen and bathroom.

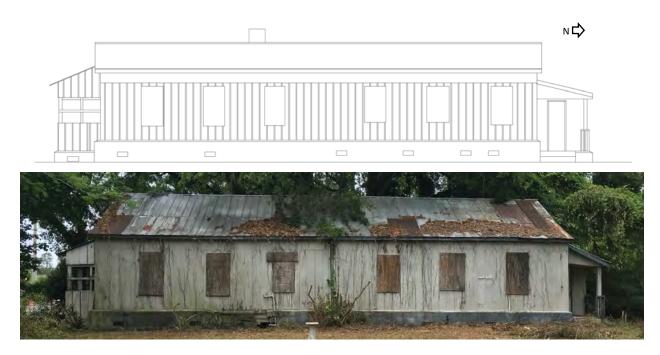
It was also during this period that a concrete block pseudo-foundation was installed around the base of the structure, perhaps to inhibit animals from occupying the space below the structure. Sections of this addition were falling away at the time the building was recorded. There are vent holes installed in the concrete block foundation as well. The T1-11 pressure treated sheathing was installed during the period. The elevation photograph and drawing below depict the structure as it now stands on the property.
