# A Preliminary Architectural Assessment of the Long Point Road Elementary School in the Snowden Community, Charleston County, South Carolina

#### **Project Introduction**

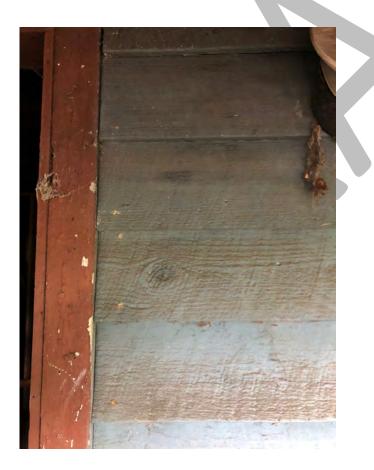
entrance. It was painted blue with red trim

The door depicted in the earliest photograph of the structure is no longer present (Figure XX). The interior space in this initial structure was painted white as all of the wall framing and joists are this color. There is a distinct line on all the vertical joists indicating where a ceiling once was in the original building. The exterior was also white during this phase as indicated in areas where later colors of paint have flaked off. The latest color scheme can be seen in the image to the left from the front

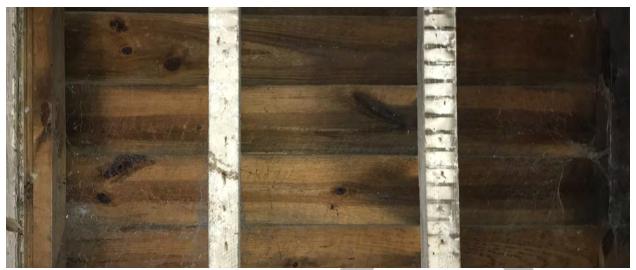
Modifications of the original building were extensive at this point. It is clear that the majority of clapboards were replaced as well as the roofing system during Phase II. Other modifications also include the installation of beadboard on both the ceiling and the walls. Beadboard was popular in urban contexts beginning in the 1870s and continued to be used in rural areas through the 1930s and thus is not unusual to find it on this structure. The beadboard was removed in the Phase I area after a fire sometime in the 1990s as can be seen below. A porch was added to the front during this phase and the original brick steps were moved to accommodate this addition.

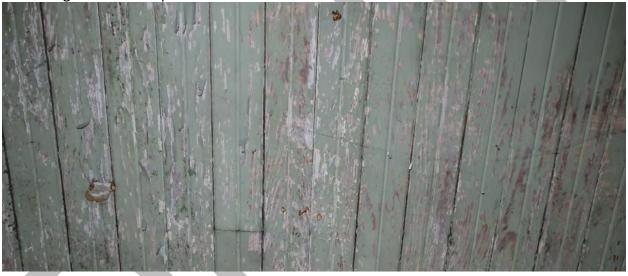
It was covered by plasterboard in the extension sometime in the 1980s. The beadboard can be seen in Figure XX where plasterboard has been removed.

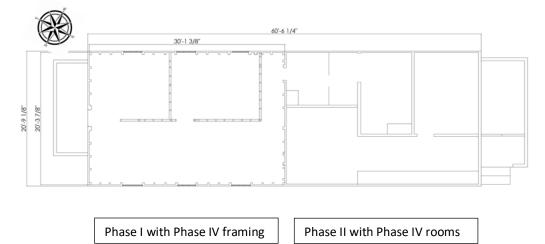
A relatively recent fire resulted in the removal of the majority of beadboard in the Phase I section of the structure. This exposed the original framing. New rooms have been framed but not drywalled in the Phase I area. The Phase II portion of the structure has been completed with two bedrooms, a sitting room, kitchen and bathroom.

The plan view also illustrates these modifications.
